NPIC/R-225/64

BLAGODATNOYE AMMUNITION DEPOT SOUTH AND OTHER INSTALLATIONS NEAR BLAGODATNOYE, USSR

PHOTOGRAPHIC INTERPRETATION REPORT

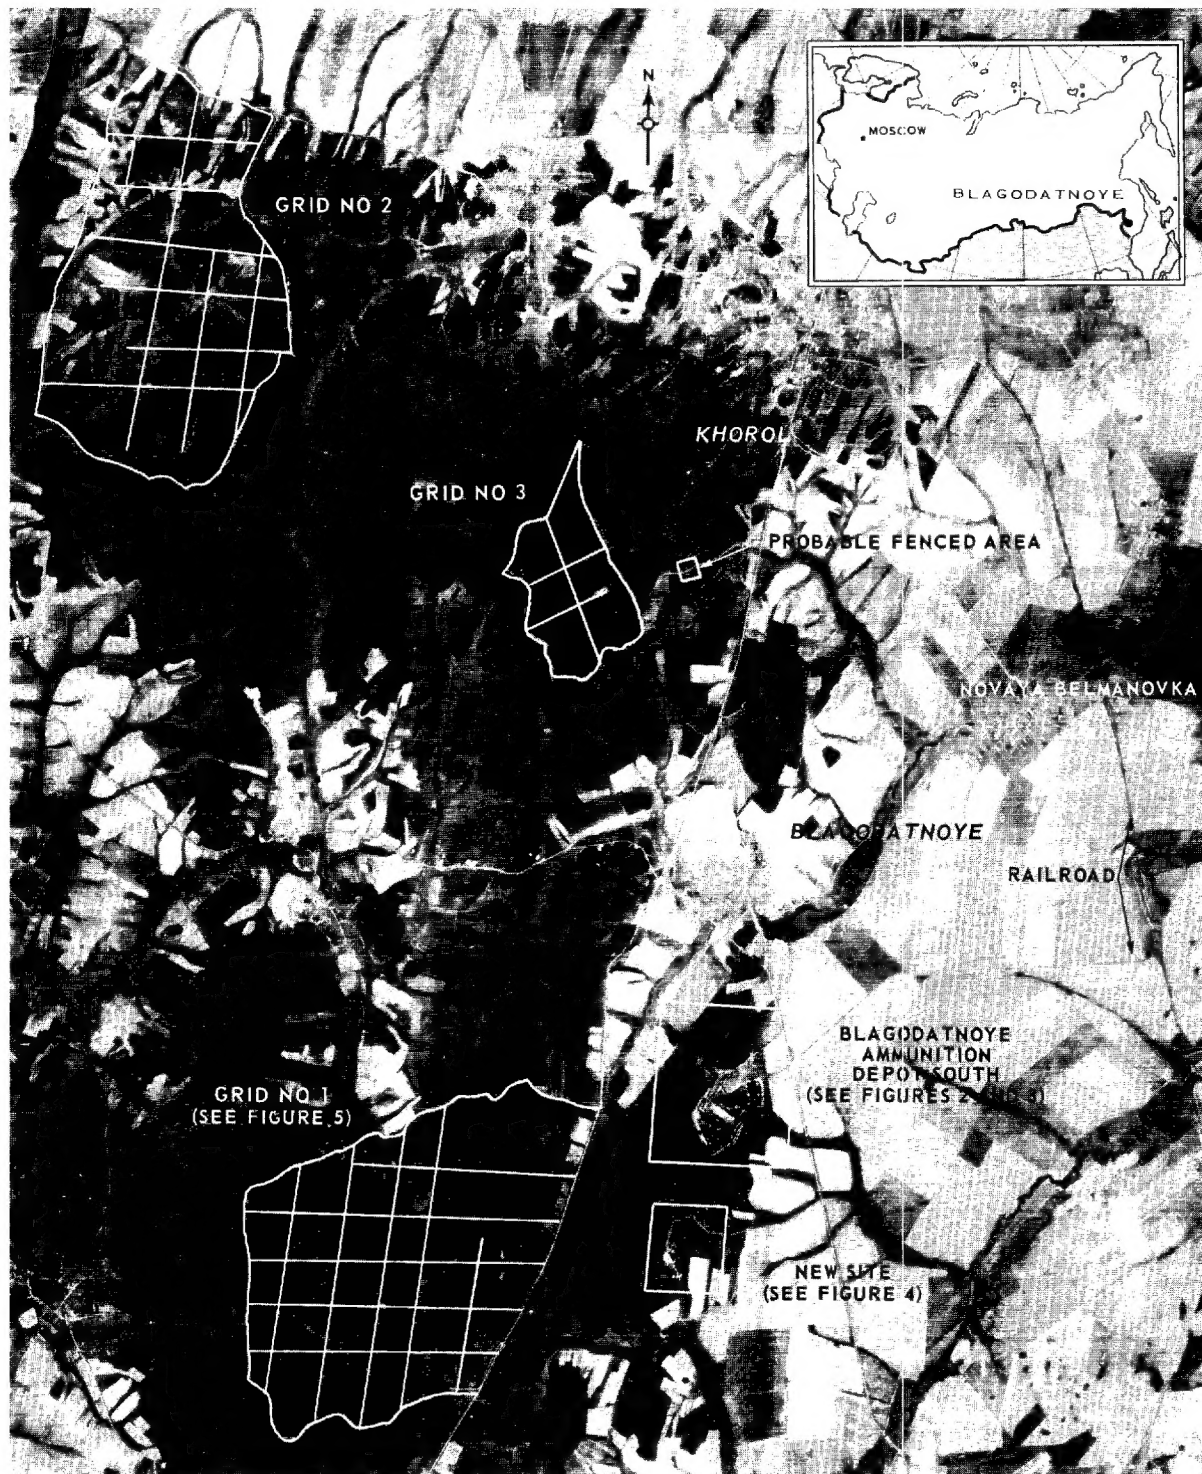
FIGURE 1. INSTALLATIONS NEAR BLAGODATNOYE, USSR, [REDACTED]

The second purpose of the report is to describe three grids, a new site, and a probable fenced area in the vicinity of the Blagodatnoye Ammunition Depot South. The location of these installations and their spatial relationship is shown in Figure 1.

Grids. Three grids, observed on [REDACTED] photography in the vicinity of the Blagodatnoye Ammunition Depot South, are designated Grids No 1, 2, and 3 (Figure 1). All three grids are located in very rough terrain, which is covered with scrub vegetation. Also, in all three grids the spacing of the grid lines is of the same order of magnitude, but the actual distances between adjacent lines are variable.

Probable Fenced Area. A rectangular area, approximately 800 by 600 feet, probably fenced, is situated on the southeastern edge of Grid No 3 (Figure 1). Within this area are 16 small, regularly spaced white spots which may indicate buried tanks of some kind, possibly fuel tanks for one of the nearby airfields.

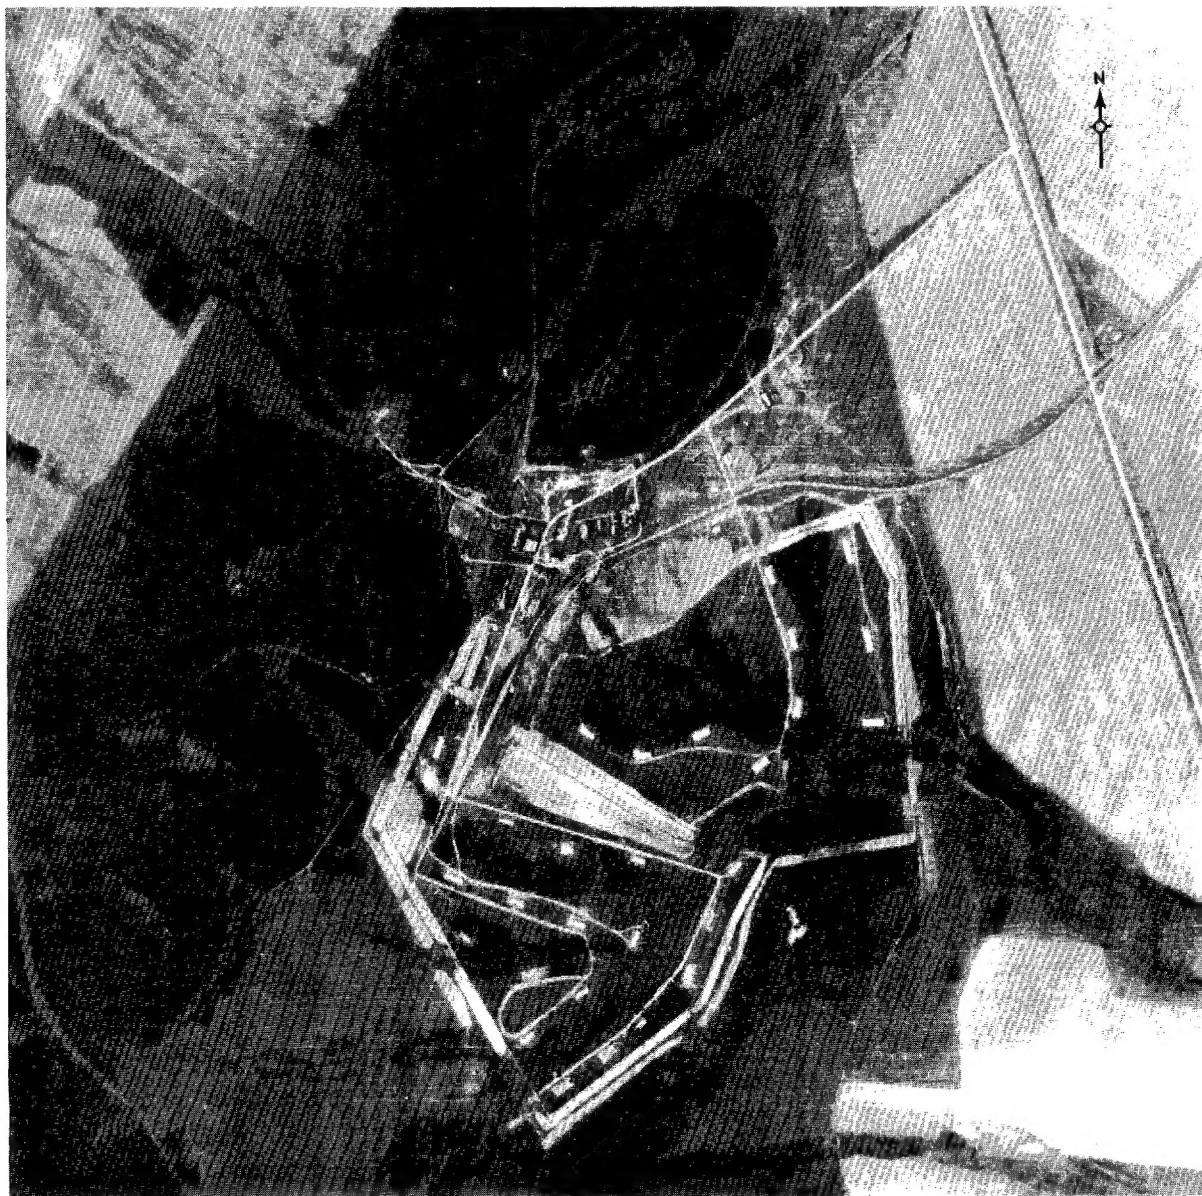
FIGURE 2. BLAGODATNOYE AMMUNITION DEPOT SOUTH, [REDACTED]

Blagodatnoye Ammunition Depot South (BE No [REDACTED]) is located approximately 3 nm south of the village of Blagodatnoye and about 10 nm south of the town of Khorol in Primorskiy Kray, USSR (Figure 1). The depot comprises a separately fenced warehouse area, five

bunkered storage areas, and a servicing and administration area. A rail spur from the Khabarovsk-Vladivostok section of the Trans-Siberian Railroad terminates at the depot (Figures 2 and 3).

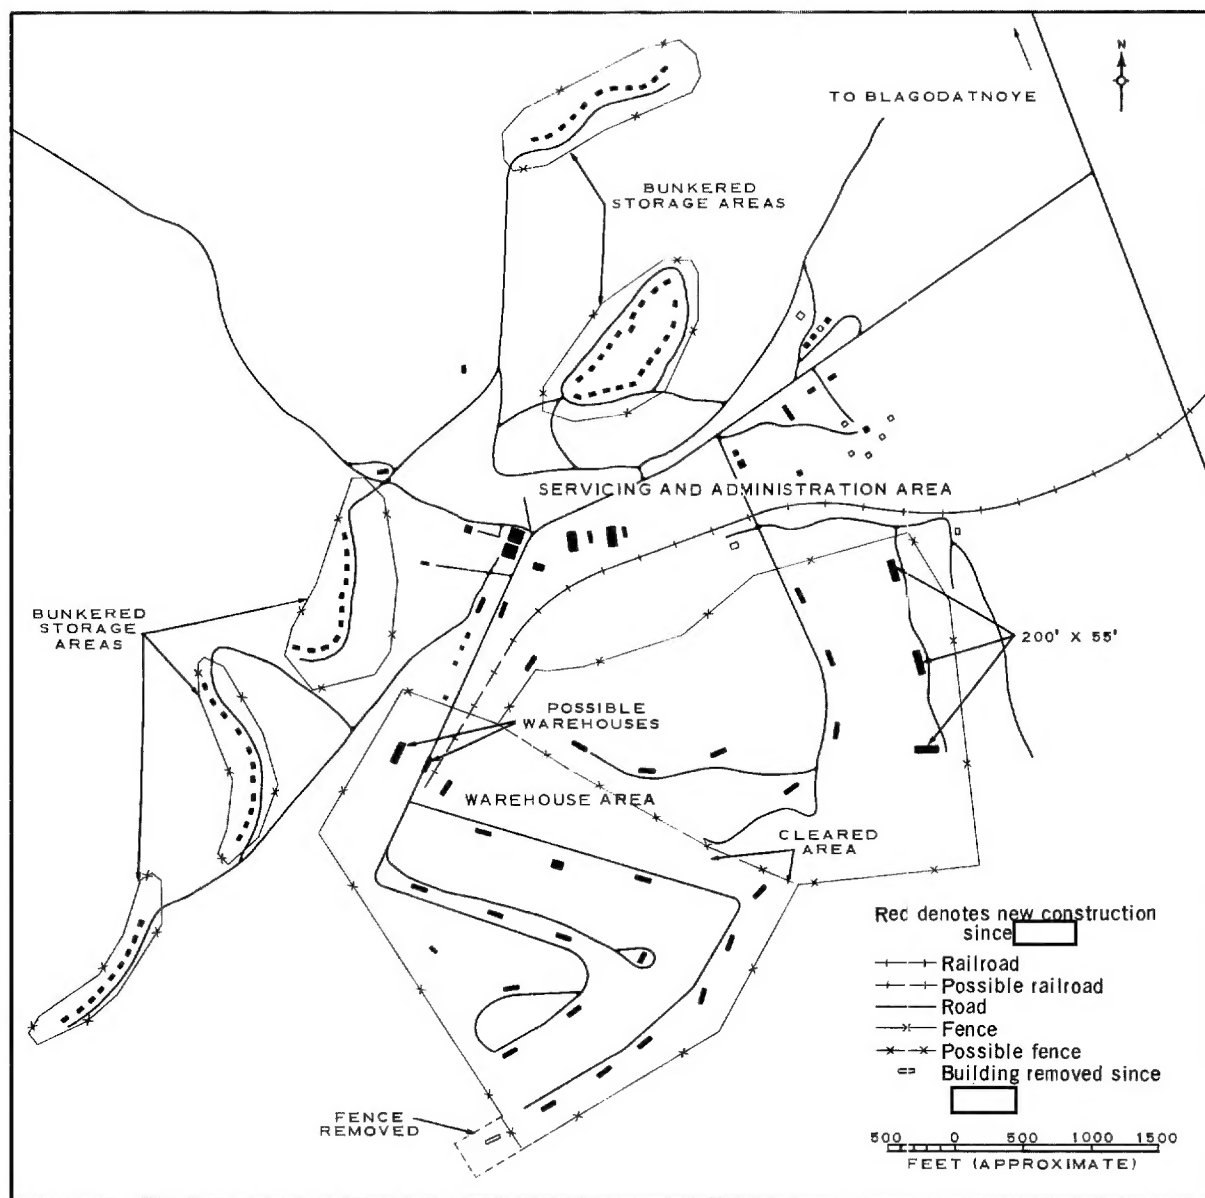
FIGURE 3. LAYOUT OF BLAGODATNOYE AMMUNITION DEPOT SOUTH.

Warehouse Area. The warehouse area consists of an irregular, fenced compound of about 680 acres; it contains 28 storage buildings of which 25 are set in recesses and are probably revetted. Three conventional warehouse-type buildings located in the northeastern part of the

warehouse area are not set in recesses and are probably not revetted. They measure approximately 200 by 55 feet. The other 25 storage buildings measure approximately 145 by 50 feet. Since two possible warehouses have been constructed on the western side of the

compound. No ventilating devices are discernible on any of the buildings. The total floor-space of the warehouses is approximately 214,250 square feet.

Bunkered Storage Areas. Approximately 63 bunkers, arranged in five groups, are located north and west of the warehouse area. Each group of bunkers is secured by a single fence. On poor-quality photography of [REDACTED] the bunkers appear as low, earth-mounded rectangular structures protruding a few feet above ground level; some of the bunkers are surrounded by a low earth revetment, apparently for drainage control. In [REDACTED] the bunkers appeared to be abandoned. Measurements made on this photography suggest that each bunker is about 40 by 20 feet; the earth mounding and associated revetments obscure the exact outlines of the structures. On photography of [REDACTED] the bunkers are poorly defined, irregular objects arranged in five arcuate patterns. The bunkered storage gives the impression of being little used. Inasmuch as the facility is located within

Servicing and Administration Area. About 24 buildings are located between the warehouse and bunkered storage areas of the depot; approximately 12 of the buildings have been constructed since [REDACTED]. These buildings probably house the servicing and administration functions of the depot. The large number and varied configuration of the nonstorage-type buildings suggest that the depot is engaged in the servicing, renovation, or modification of the munitions stored there.

Security. A wide security strip has been cleared nearly all the way around the warehouse area of the depot. A possible interior fence has been erected that divides the warehouse area into approximately two equal parts. The security fence at the southern end of the warehouse area has been straightened since [REDACTED] a storage building has been removed to permit the fence realignment.

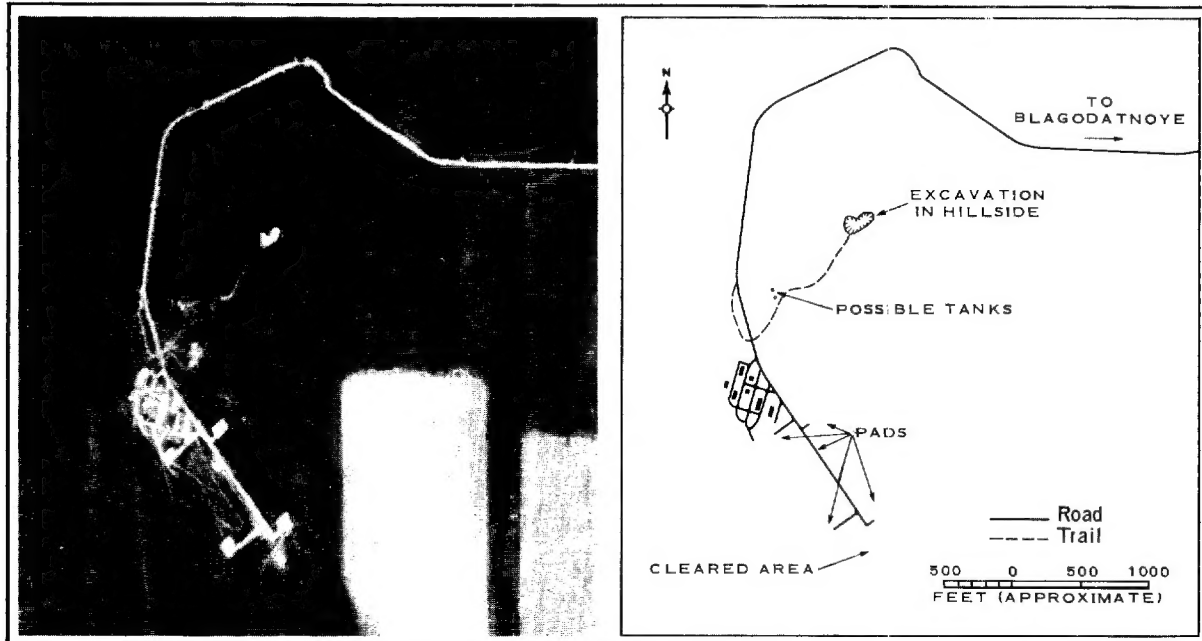
FIGURE 4. NEW SITE, [REDACTED]

New Site. A new site is situated approximately 1.5 nm south of the Blagodatnoye Ammunition Depot South (Figure 1). The site consists of seven buildings of various sizes and five rectangular pads; the pads are located along an extension of the access road (Figure 4). This site was under construction in [REDACTED] four of the five pads were present at that time. The site has no apparent relationship to the Blagodatnoye Ammunition Depot South. The pads suggest parking spaces for mobile testing or metering equipment such as radars, telemetry receivers, and similar equipment.
